MR-J3-□A-RJ158 + MR-J3-T04 (EtherCAT Servo) Trouble Shooting Guideline (Document for oversea sales office)

Mitsubishi Electric Corporation, Nagoya Works

2. Point of EtherCAT Packet Analysis

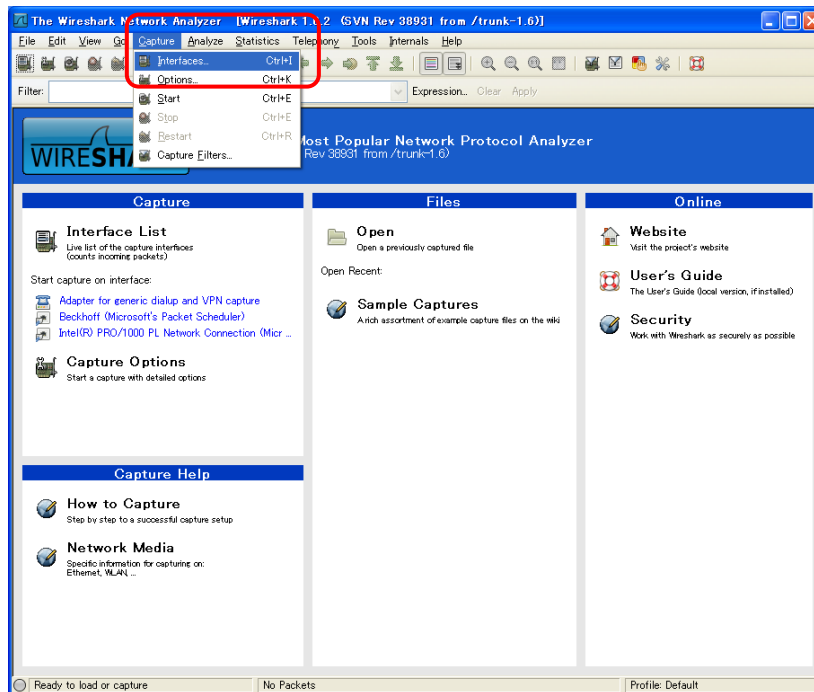
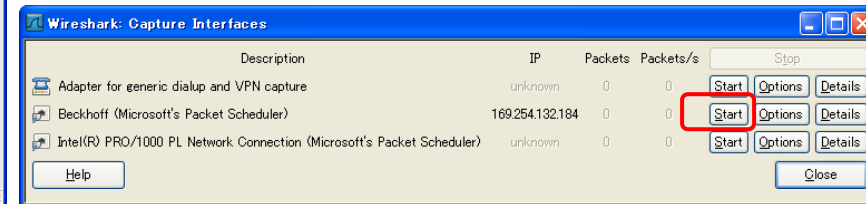
Before start capture, please select “[Capture] – [Interfaces].” Then, please select the Network interface for the target log data.

Right bottom window is example in case of Beckhoff LAN card is used for EtherCAT communication at PC which has Beckhoff FC9011 LAN card and Intel embedded LAN adapter.

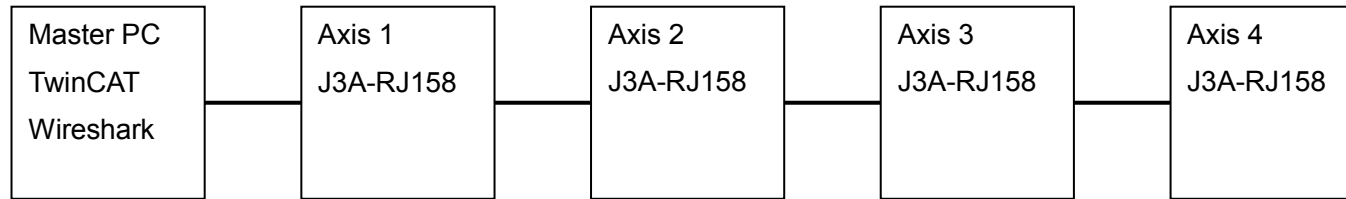
From this page, here is capture example in case of 4 axes servo with PC which has TwinCAT and Wireshark.

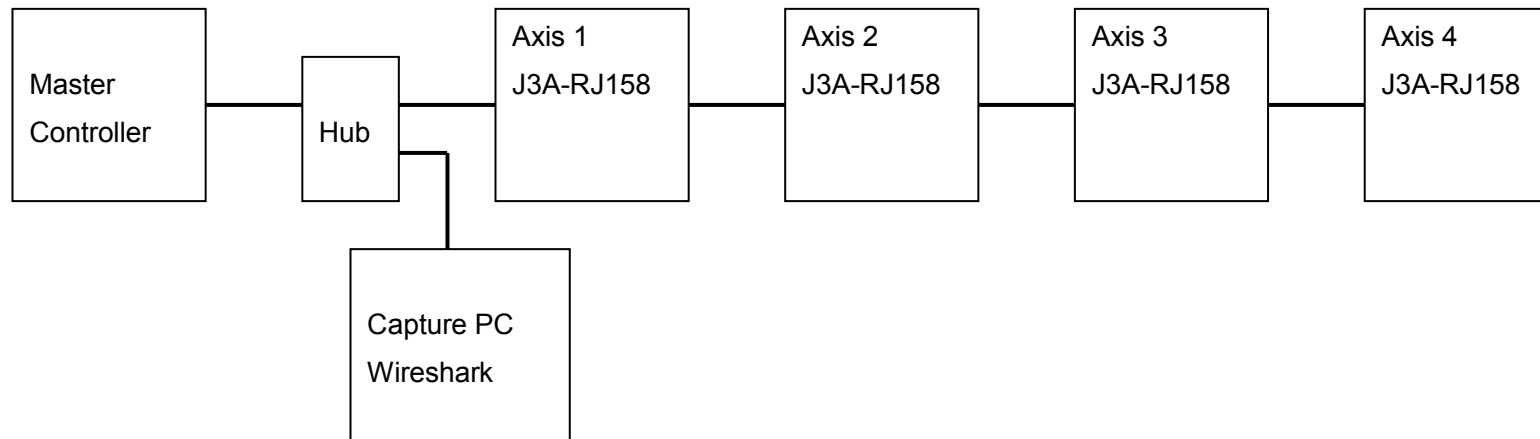
If Wireshark can not be installed to master controller, alternative idea is to install Wireshark into other PC which is connected to system via hub. (This is inappropriate method for strict timing investigation, because there is a hub in communication path.)
